PHOTO LOG FOR INSTALLATION OF THE LNAPL RECOVERY SYSTEM RANDALL TEXTRON SITE GRENADA, MISSISSIPPI

ROCKWELL INTERNATIONAL CORPORATION Automotive Operations 2135 West Maple Road Troy, MI 48084

ECKENFELDER INC.® 227 French Landing Drive Nashville, Tennessee 37228 (615) 255-2238

November 1993

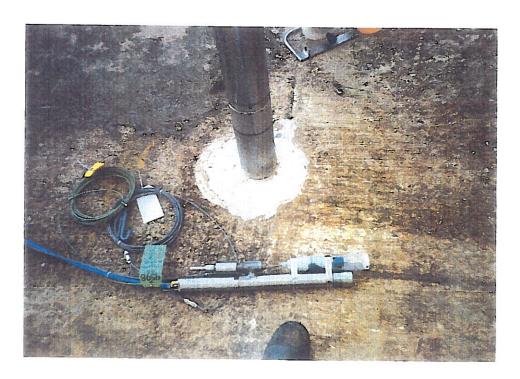
LNAPL Pump with Conductivity Sensor and Float Switch.

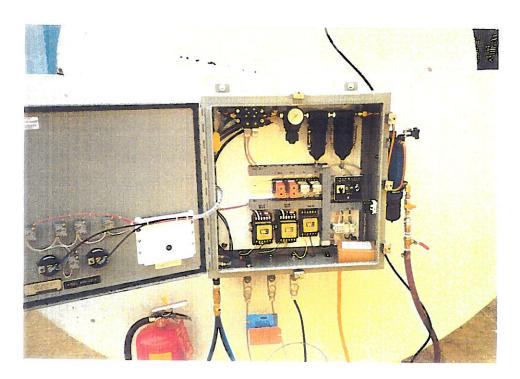
Inside of Controller. Two Pumps Connected to Controller.

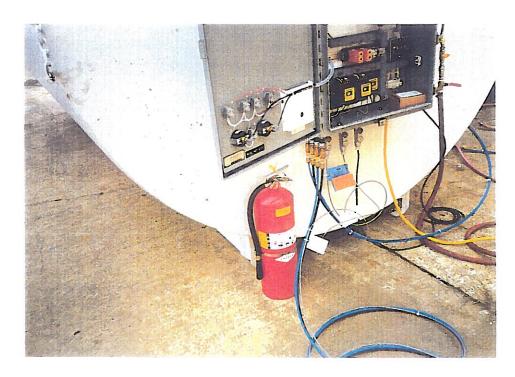
Fire Extinguisher.

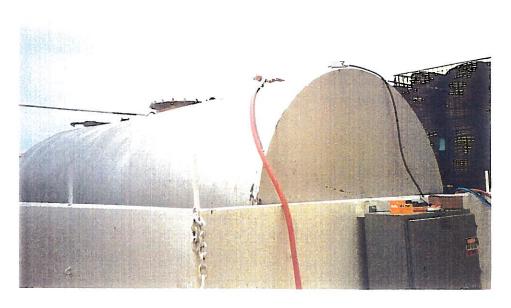
Product Line Connected to Recovery Tank and Tank Float Shut-off Assembly Installed.

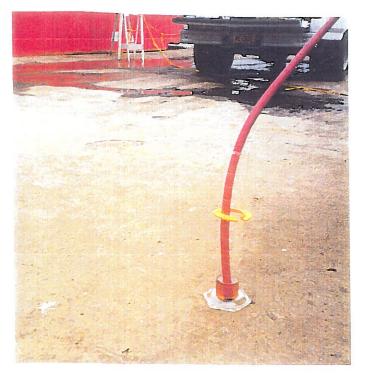
Checking Flow Rate of System. No Water was Pumped During Test.

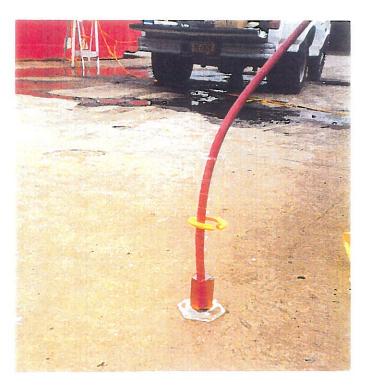
Checking Flow Rate of System. No Water was Pumped During Test.

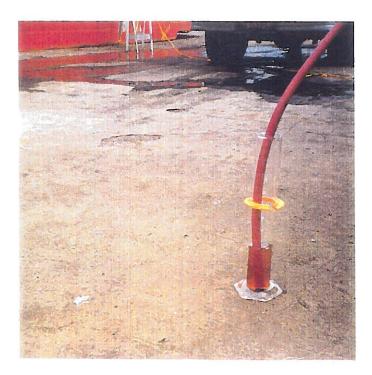
Checking Flow Rate of System. No Water was Pumped During Test.

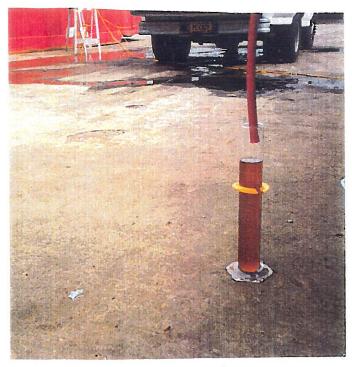
Checking Flow Rate of System. No Water was Pumped During Test.

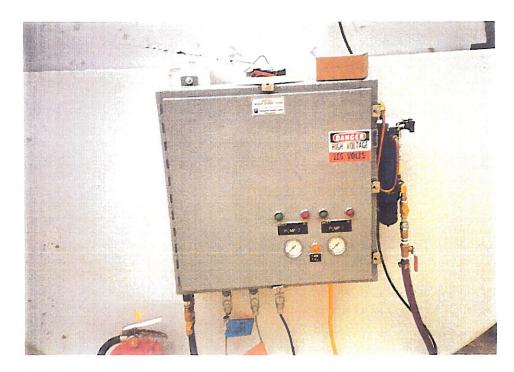
Controller: Conductivity Sensor and Float Switch Signals That Water is Present at Both Pump Intakes; Both Pumps <u>Not</u> Pumping.

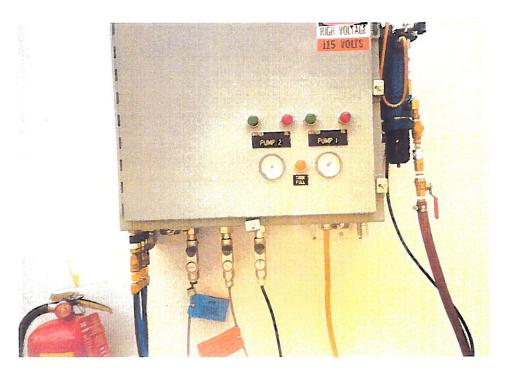
Controller: Conductivity Sensor and Float Switch Signals That Product is Present at Pump 2 Intake, but not at Pump 1; Pump 2 is Pumping.

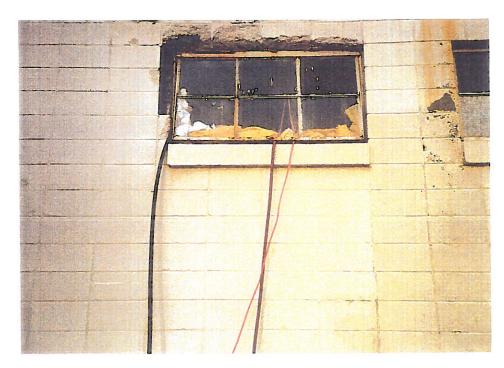
Plant Air, Electric, and Tap Water Supply.

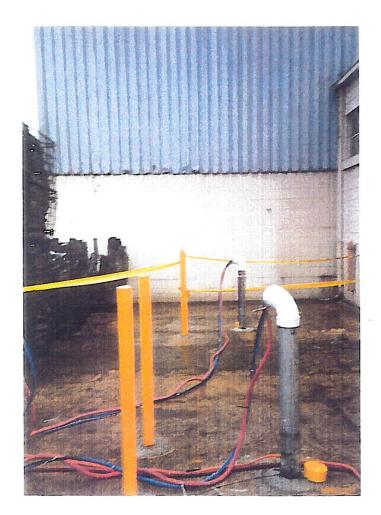
Pump 1 Installed in Well RC-2 and Pump 2 Installed in Well RC-4.

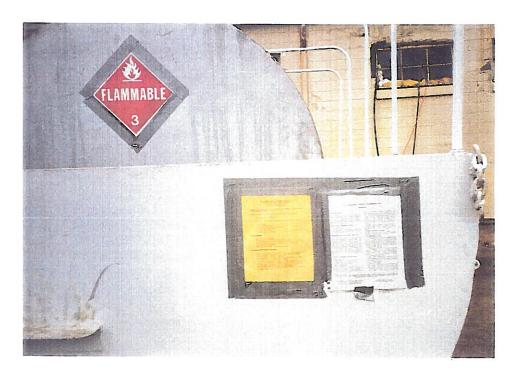
Spill Prevention and Response Plan and MSDS Posted.

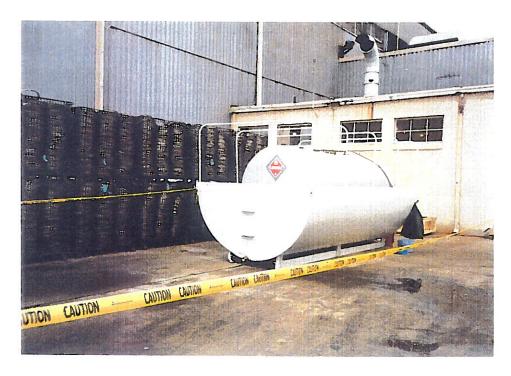
LNAPL System Area: Product Recovery Tank with Secondary Containment. Tank and Secondary Containment Will Be Covered to Prevent Storm Water Accumulation.
